# Aeration Case Study: Bahia Del Mar Lake Restoration

In January, 2012, the Bahia Del Mar HOA contacted a local lake management company to request assistance in dealing with their 14 acre lake with issues including bad odors, dead fish and other wildlife and green murky water.

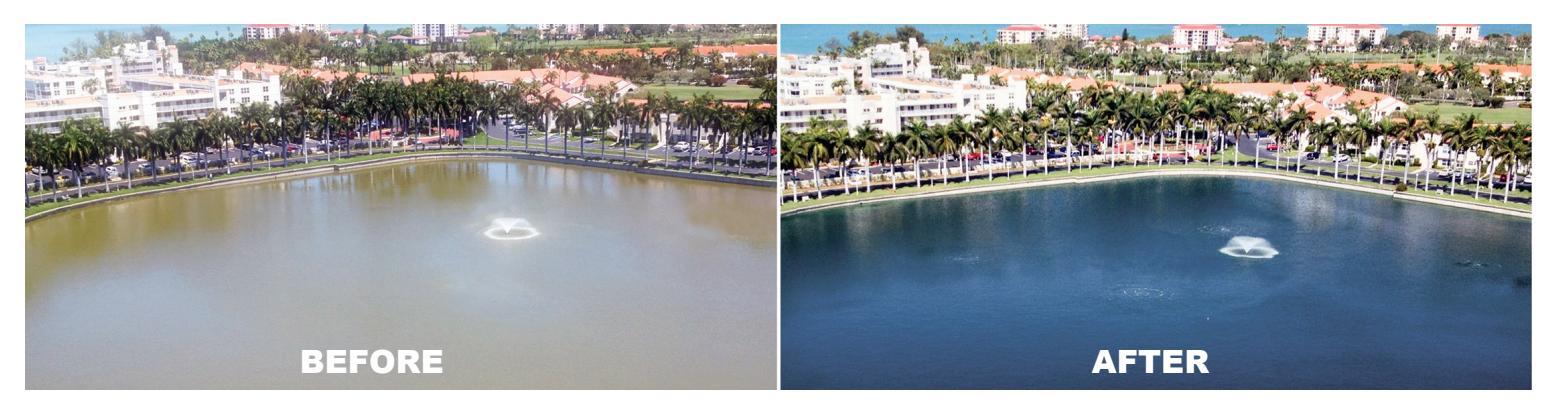
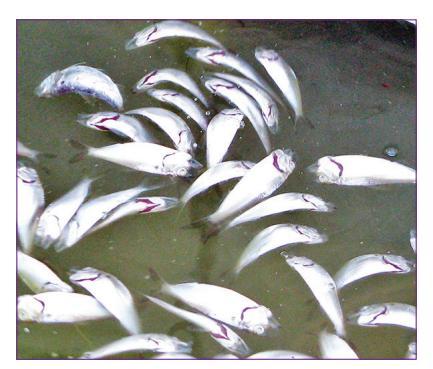
A major fish kill that occurred in January, 2012 was likely due to rapid mixing of stratified layers by an existing aeration system installed by a previous lake management company. The system was undersized and installed only in the shallower areas. This undersized system was only strong enough to churn up water from the bottom of the lake without properly mixing and adding oxygen to the entire water column.

This rapid mixing of bottom layer waters into the upper water levels depleted all the oxygen in the surface water and brought up high levels of hydrogen sulfide, methane and ammonia from the bottom waters up to the surface causing the death of fish, crabs, shrimp, snails and some birds in the lake.

Dead fish, birds and crabs were common before the restoration.

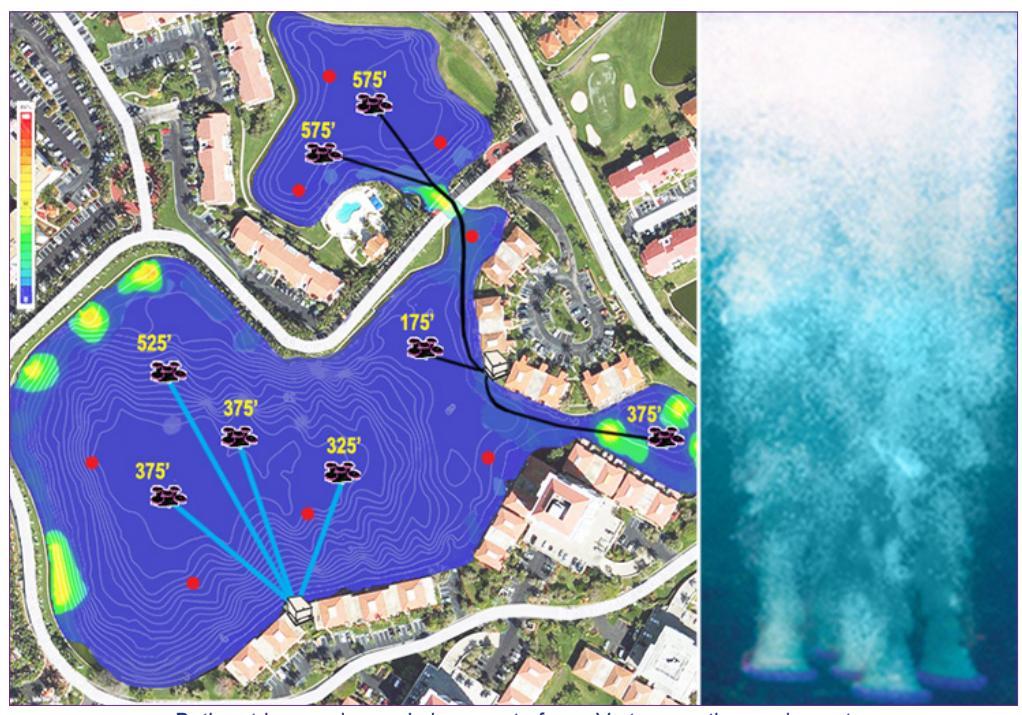
We had been told that the lake was only 18' at it deepest point. To confirm this, we conducted bathymetric mapping which allowed us to determine accurate depths throughout the lake, the total water volume and the location of vegetation in the lake. Contrary to what we were told, mapping showed areas within the lake that were actually over 50' deep.

This information allowed us to determine exactly how much aeration was needed to circulate the entire water body each day; and to identify the best locations in the lake for placement of the aeration.

Bathmetric mapping and placement of new Vertex aeration equipment

A much larger customized Vertex Aeration System was installed in the lake to effectively circulate the water.

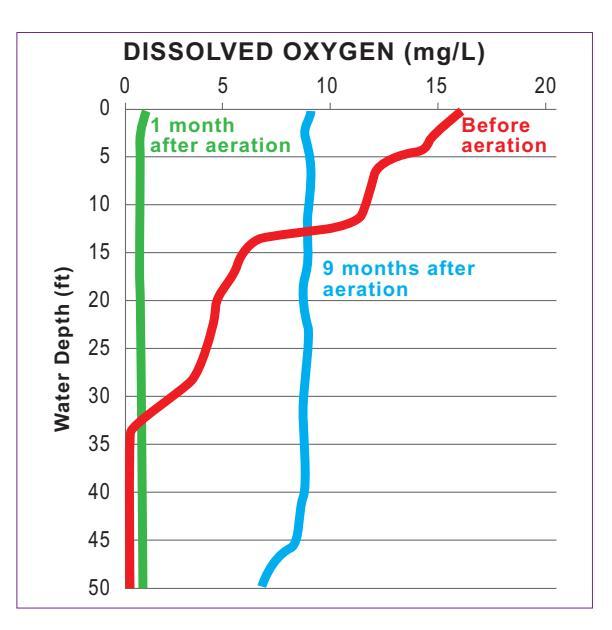
Prior to aeration installation the water was stratified, with very high oxygen levels (12 to 15 mg/L) at the surface and little to no oxygen (0 to 1 mg/L) in deeper waters. This is often seen in lakes with algal blooms, where the high surface oxygen levels reflect the oxygen producing activity of large quantities of photosynthesizing phytoplankton in the surface waters. Although oxygen at the surface is high during the day, at night, oxygen consumption by the same plankton would decrease oxygen levels, creating stressful conditions for fish and other aquatic life.

After Vertex aeration was installed in the lake, stratification was eliminated and the water mixed evenly, but oxygen levels were very low (< 1mg/L). However, after 9 months of continuous aeration, the oxygen levels throughout the water column remained around 8mg/L (even at a depth of 50ft), better than what would be expected in a healthy lake.

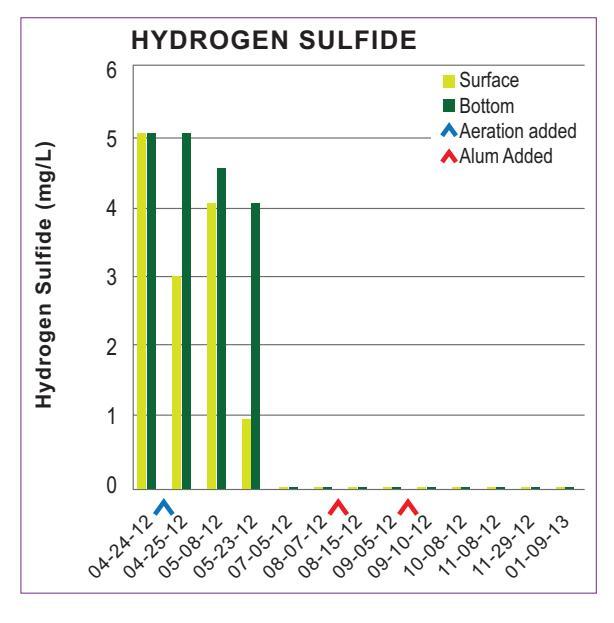
Hydrogen sulfide concentrations began to decrease following the installation of Vertex aeration and the gas was completely undetectable in the water after 10 weeks of continuous aeration.

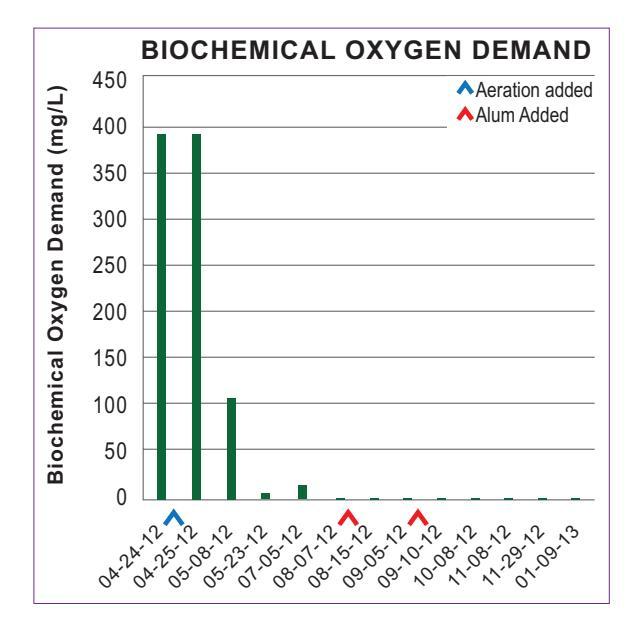
Initially BOD levels were similar to what might be observed in a sewage treatment plant (> 350 mg/L). There was a large amount of organic matter in the lower water column and all the available oxygen had already been used up, which is why oxygen levels were so low. After the installation of Vertex aeration, the BOD decreased dramatically and is currently at or near 2 mg/L, inndicating a healthy lake system.

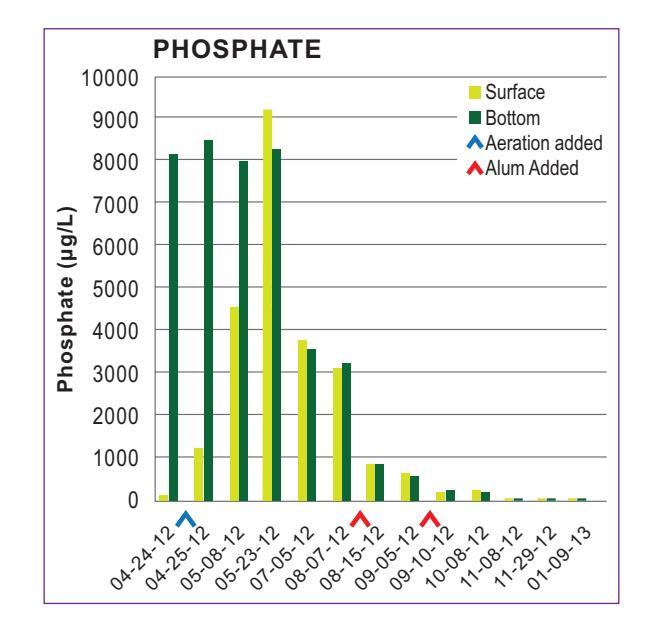
Oxygen promotes the binding of phosphorus to minerals such as iron and manganese, and once bound within the sediment, phosphorus is effectively kept out of the water column. Therefore, following the installation of Vertex aeration, although phosphorus levels initially increased after the water was first mixed, there was a subsequent decrease over time, from > 8000 µg/L to ~3000 µg/L. After the two subsequent Alum treatments, levels were further reduced and now consistently remain below 60 µg/L, which is well within the desired range for this lake.

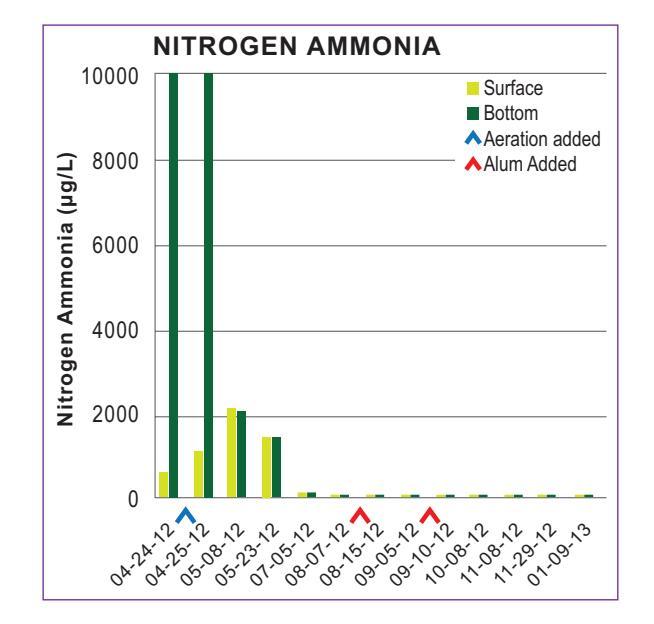
Oxygen promotes the conversion of ammonia to non-toxic forms of nitrogen and also facilitates the removal of nitrogen from the water as a gas. Following the installation of Vertex aeration nitrogen levels were reduced from > 100,000  $\mu$ g/L to 800  $\mu$ g/L. After the two Alum treatments, levels were further reduced and now fluctuate between 600 and 900  $\mu$ g/L, with the fluctuation being due mainly to excrement from fish feeding on plankton in the water column and possibly runoff of fertilizers applied to adjacent lawns.
